# Lever handle L

## Knud Holscher collection

| Product | 16L, pair, 8x8mm, solid rose, cc 30mm, 33-59mm. |

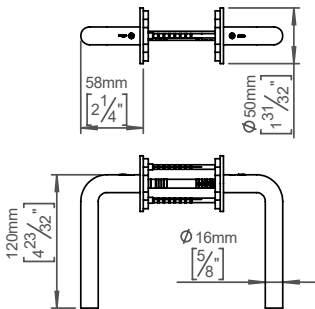
| Product specification | Dimensions: 137x50x58mm<br>Diameter: Ø16mm<br>Material: stainless steel AISI 316<br>Surface finish: satin grain 320, crafted by hand<br><a href="#">20-year warranty (5 years for coated items)</a> |
