Built-in touchless tap

Qtoo collection

Product 190mm built-in infrared touchless tap

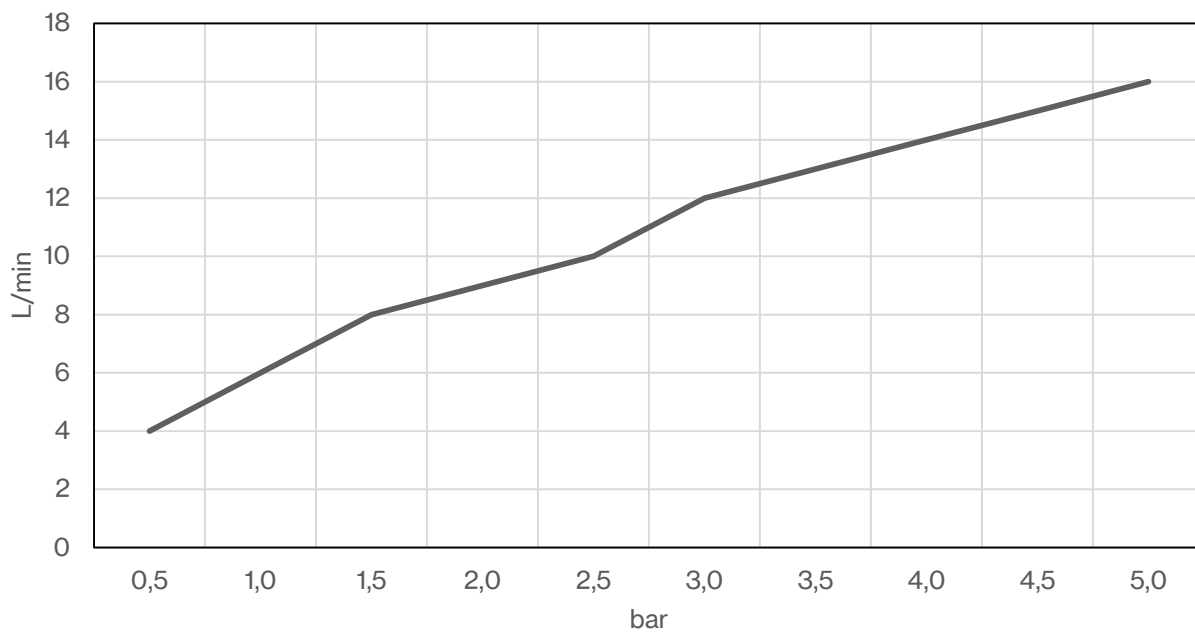
QST3190 flow rate (without aerator)
